KSZ8041

KSZ8041 Silicon Errata and Data Sheet Clarification

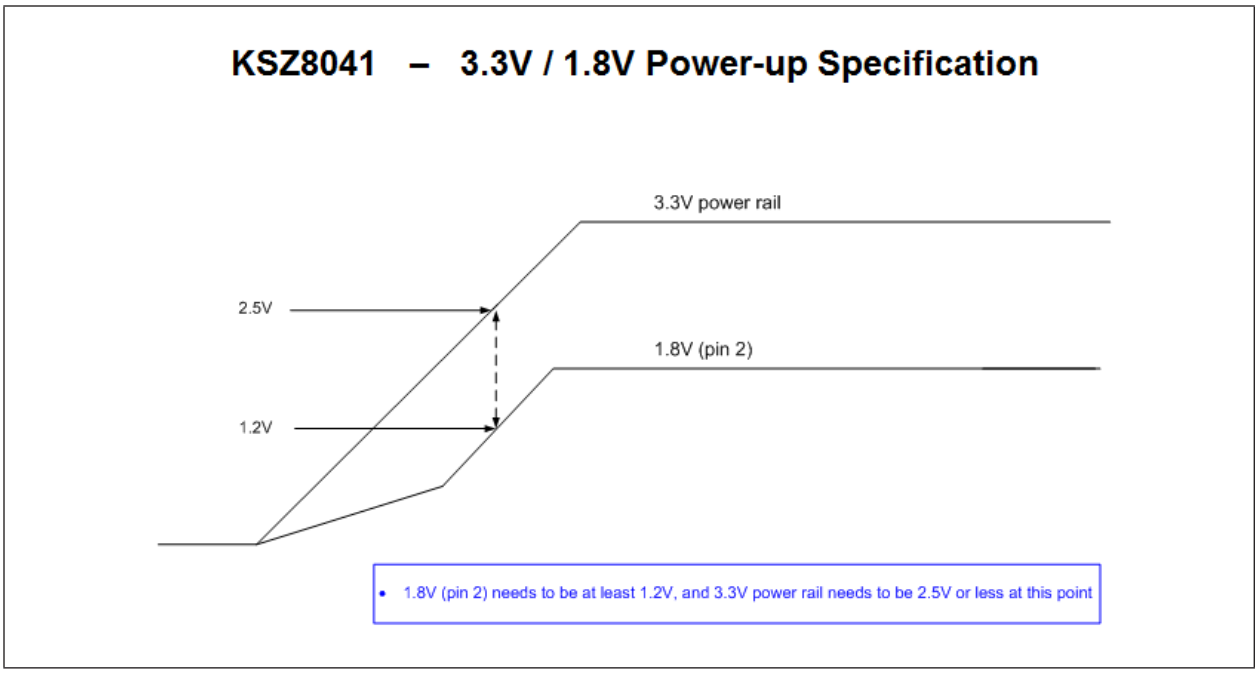
Module 2: Pin Strapping failures due to 1.8V core power slow ramp-up

A small percentage (<1%) of devices can potentially encounter pin strapping failures with fast 3.3V supply rise times (<150us) or slow core rail rise times, due to a large bulk storage capacitor value (10uF or greater) for the 1.8V core.

When this errata occurs, pin strap values may not be correctly latched.

Reduce the 1.8V core bulk storage capacitor from 10uF to 1.0uF and ensure the 3.3V supply rise time is 250us or greater.
